Customer Notification

IE-703288-G1-EM1TM

In-Circuit-Emulator

Operating Precautions

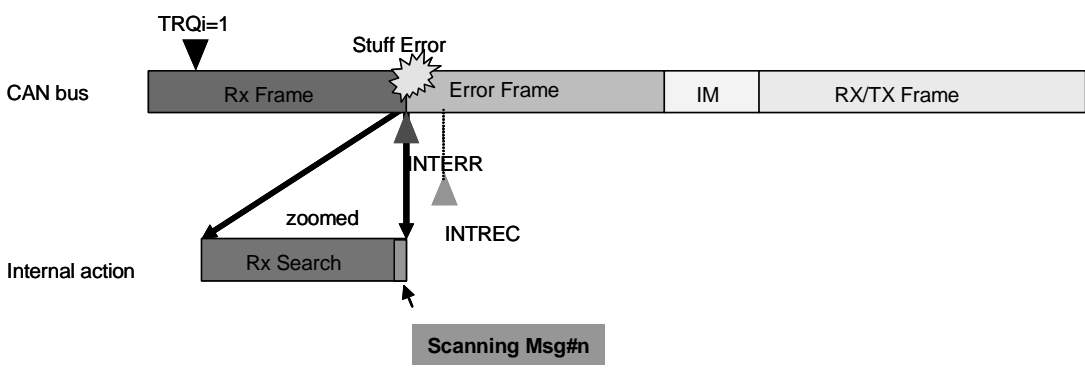
No. 17	aFCAN: Rx limitation (Technical limitation)
	<p><u>Details</u></p> <p>RX Limitation</p> <p>The aFCAN macro may store an incoming message although this message was interrupted by a bus error frame. Thus, the incomplete reception causes that a message buffer is updated with old or incorrect data or that the message is even stored at an incorrect location.</p> <p>This unexpected behaviour affords that the bus error occurs in a certain relation to the currently present message on the bus. The critical time window starts at the sample point of the LSB of the DLC-field and lasts for the duration of an internal process in the aFCAN macro (RX-search). This time window usually lasts for a few bit times only. The actual length depends on the clock supply for the AFCAN, the CPU accesses during this period, the baud rate and the number of message buffers of the particular AFCAN macro.</p> <p>In this time window the RX-search evaluates the received identifier of the current message. When the bus error is detected within this window and when the RX-search has just scanned buffer #n for reception and found it is matching, the message will unexpectedly be treated as a received message. As the time window is limited as described above, only a stuff bit error occurring right in this window can cause this behaviour.</p> <p>There are two types of unexpected behavior for the RX limitation depending on the presence of pending transmission request (TRQ) for any other message buffer.</p> <p>1. Behaviour at pending TRQ (TRQi = 1)</p> <p>When the host processor has already submitted a transmit request (TRQ) for at least one buffer, the unexpected reception of the message will take place into the message buffer found by internal RX-search. This is the correct location to store the message i.e. the acceptance filter criteria are correctly fulfilled. However the data part will be updated with the contents of the shift register of the CAN protocol core. As this register is immediately stopped at detection of the bus error, the data provided to the message buffer can not be interpreted by the host processor.</p>

<p>Figure 1: Behavior at pending TRQ</p> <p>As during a regular reception, the RX-interrupt (if enabled) is generated and the application processes the message object.</p>

No. 17	aFCAN: Rx limitation (Technical limitation)
	<p><u>Workaround</u></p> <p>NEC will update the affected products.</p> <p>NEC does not recommend a S/W workaround as first choice as it is fairly complex. On the one hand it is based on the control of submitting transmission requests only when the bus is idle. On the other hand a less complex algorithm can be used which does not prevent the unexpected reception but detects it safely and discards the unexpected reception in the CAN S/W driver. Any of these algorithms require that message buffer #0 is not used or that a 'dummy' TRQ in an unused buffer is set. This prevents behaviors as described in 2.</p>

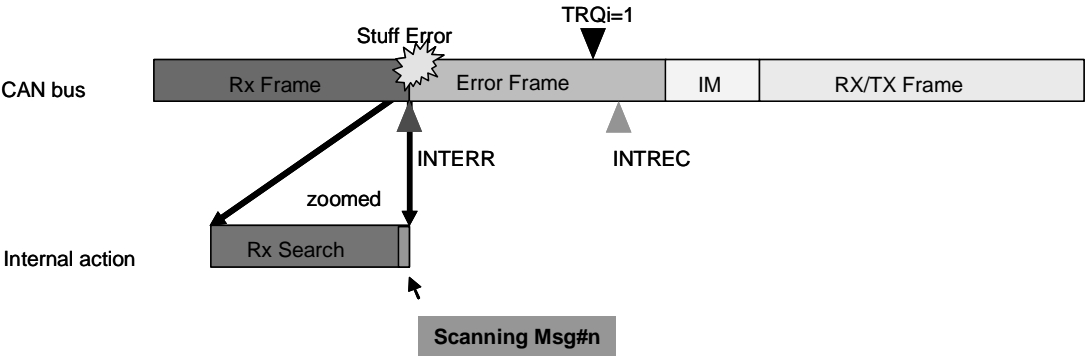
No. 17	aFCAN: Rx limitation (Technical limitation)
	<p>2. Behavior without pending TRQ (TRQi = 0)</p> <p>In case the host processor has not submitted a transmit request (TRQ) for any buffer before the detection of the bus error but submits TRQ = 1 after that point in time (see figure below) before the re-transmission of the message interrupted by the stuff bit error started, the unexpected reception of the message will take place.</p>

<p>Figure 2: Behavior without pending TRQ</p> <p>The unexpected storage of the message is issued in the particular message buffer that matches the acceptance filter criteria at the time where the bus error is detected (as described in 1.) or the message buffer #0 is overwritten independently of its configuration.</p> <p>Impact on application</p> <p>In typical applications the RX-limitation will lead to transiently incorrect data. In the vast majority of cases the message interrupted by a bus error is repeated by the transmitter right away. Then the application receives correct data shortly after the unexpected reception.</p> <p>In scenarios where the message buffer #0 is overwritten, the impact for the application depends on the usage of that buffer. If it is configured as a receive buffer, the application receives a message at an unexpected location and will interpret the data to belong to the identifier originally programmed for that buffer. The message buffer #0 needs to be re-configured in order to receive the originally intended message object again.</p> <p>In case of a transmit message buffer the unexpected storage may falsify a transmit object; i.e. when the unexpected behavior occurs after preparation of the message data but before the actual start of transmission. This scenario is even less likely than the scenario described in 1, which itself has a low probability. However the transmission of a falsified message can lead to repetitive transmission attempts when the original provider of that message (identifier) tries to send its message at the same time. Then the messages most likely will differ in their data part and a bit error is detected. This repetition resumes until one of the nodes enters error passive or bus off state. Then the situation is resolved as all pending TRQ are send with delay or are cancelled (in case of bus off state).</p>
