[Notes]

R20TS0545EJ0100

CS+ Code Generator for RL78 (CS+ for CC),
 CS+ Code Generator for RL78 (CS+ for CA,CX),
 e² studio Code Generator Plug-in,
 AP4 Coding Assistance Tool for RL78

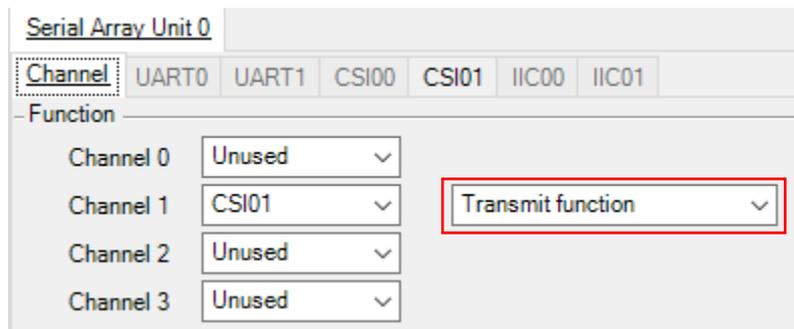
When [Transmit function] is selected in the channel settings, incorrect callback functions might be enabled in CSI or UART, resulting in generation of unintended callback functions.

When [Transmit function] is selected in the channel settings, the [Transmission end] callback function should be enabled in the [CSI01] tab. However, the [Reception end] and [Overrun error] callback functions are enabled as shown in the image below.

After setting the channels of the serial array unit, do not change the function indicated by the red frame below unless it becomes necessary to do so. If you do need to change it, make the change, then set the channel settings back to "Unused", and set the channels again.

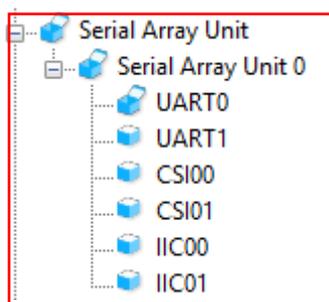
If you open an item in the [Serial Array Unit] folder again after setting CSI or UART, the pin function assignment of the serial array unit is canceled, and the pin conflict judgment does not function correctly.

If you open the item in the [Serial Array Unit] folder in the peripheral function tree, the pin function assignment is canceled.

After setting CSI or UART, do not open any item in the [Serial Array Unit] folder.

If you open an item in the [Serial Array Unit] folder and the pin function assignment is deleted, set the channel settings back to "Unused", then set the serial array unit again.
